PRE-PURCHASE SURVEY

XXXXXXX, 1980 Twister 28 Mk II

24 October 2025, at Lochin Marine, Newhaven, East Sussex, UK

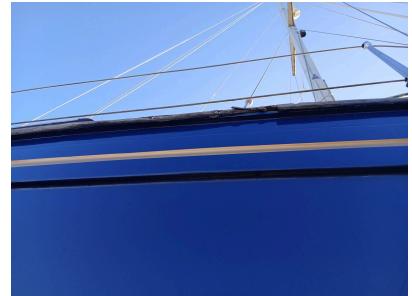
The topsides are a single-skin laminate, newly painted, with a gold-coloured cove line. The topsides were visually examined, lightly hammer sounded and checked with a moisture meter, with similar results to the hull below the waterline (10 shallow mode and 10 or less on deep mode). No signs of voids or delamination were found. No crazing was found around hard spots like bulkheads. The timber cap rail has suffered damage on each side, possibly the result of a collision. This damage runs for about 2ft (0.6m) on each side in way of the shrouds, roughly amidships. Further forward on the port side, there is further, less major damage, to the cap rail, where it has become detached from the low GRP bulwark beneath it. *Photo shows damage on starboard side*

Recommendation: repair section of toe rail on each side (B)

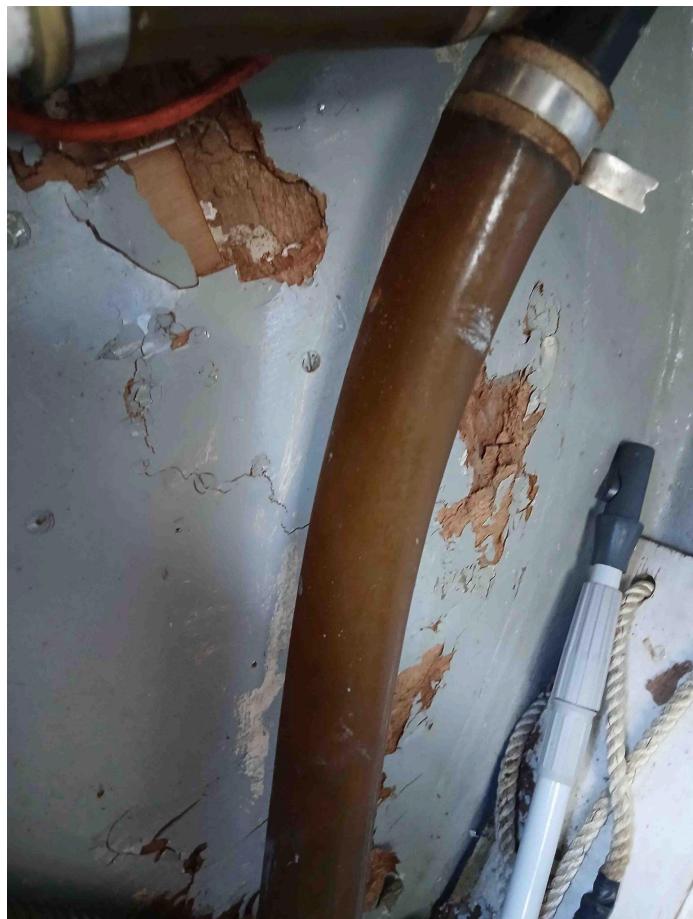
The cockpit is in generally good order, with lifting lid lockers to port and starboard and a lockable, front opening lazarette in the stern. The sole is covered by a timber cockpit grating, and has a diesel filler cap in the centre. The seats, atop the cockpit lockers, are covered by teak rails. The forward corners of the cockpit house the cockpit drains. This appears to be in good condition. The forward end of the cockpit is formed by plywood. This has rotted to an advanced stage over half the visible area (see photo below) and should be replaced like for like or with a more inert substitute like Coosa Board.

Recommendation: replace rotten plywood cockpit locker internally (B)

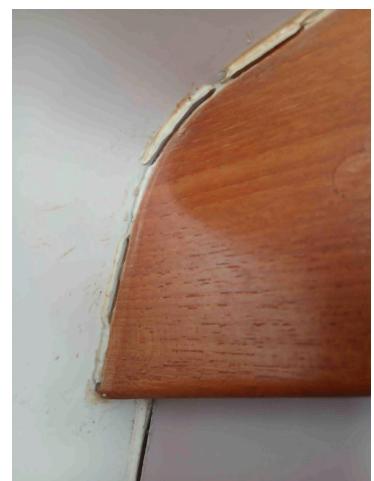
The hull gains its strength from the solidity of lay-up in mostly chopped-strand-matt GRP. Further strength is imparted by glassed-in bulkheads and partial bulkheads and this is reinforced by regular transverse stiffening floors and longitudinal stiffeners, these glassed in sections. All structural stiffeners and bulkheads were inspected where accessible. The forwardmost of the two bulkheads supporting the mast step was crudely formed where visible but reading dry and with no apparent structural defect. The aftmost of these bulkheads appears to be separating from the hull; this is likely only the timber part covering the GRP bulkheads, which appear to be firmly bonded to the inside of the hull. There is no sign of weakness, distortion, or mast compression in this area. However, the timber element of the bulkhead provides a good part of the strength in this area, and should be rebonded.

Recommendation: rebond timber bulkhead to the inside of the hull (B)

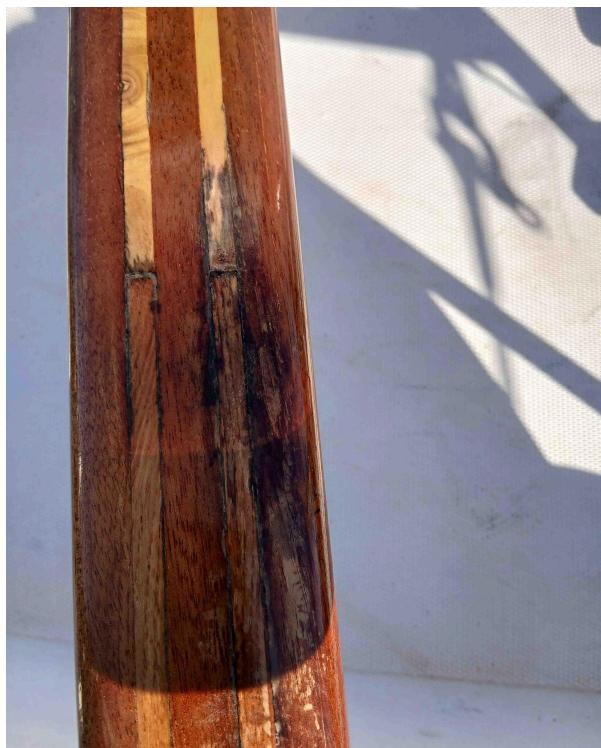
The rudder is a narrow, GRP-moulded unit, typical of Holman's design and hollow in the bottom section. It is fixed to the boat by apparently new stainless steel pintles and gudgeons and a bottom bearing. The rudder was found to swing freely and was secure against its end stops on each side. Steering is by tiller. The top (solid) section of the rudder gave moisture readings of about 25 on the comparative scale ("insignificant"), while the bottom, hollow section of the rudder was 'off scale' (100+), indicating water ingress. This is very common on GRP rudders and is not, in this instance, causing any other issues visible to the naked eye (eg osmosis, delamination or corrosion to metal fittings). The tiller, in laminated wood, shows evidence (blackening) of previous water ingress over 5in (c12cm) and on its top face, confirmed by high moisture readings in this area. There was no apparent softness upon pressure testing and the tiller should be considered functional. NB: the 'spare' tiller appears to be a new, full-sized, laminated timber replica.

Recommendation: dry rudder out in consultation with Twister 28 Owners' Association or leave as is and monitor annually for any damage (B).

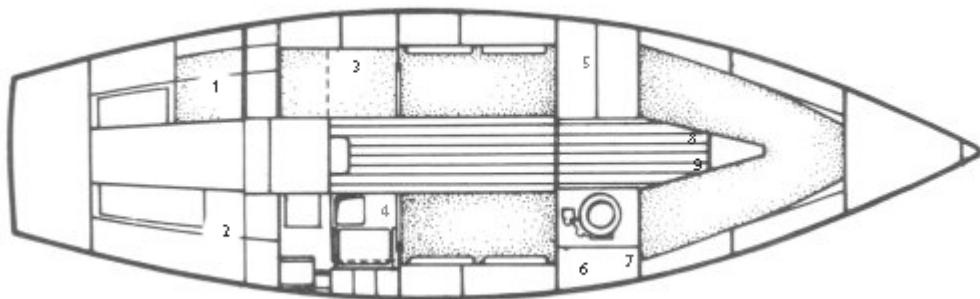
The following through-hull fittings were identified and inspected. All but 6 and 7 (heads inlet and discharge) were recently installed ball valves in good condition, many if not all, replaced since the last survey, which found various issues with existing gate valves. Numbers 6 and 7 are Blakes bronze seacock, also found to be in good condition. The two valve handles serving the cockpit drains, although in good condition, were very hard to reach. In addition to the below, there were two outlets on the transom, above the waterline. The port side outlet (looking forward) is the engine exhaust and the starboard outlet is the bilge pumps' outlet. These, and all other seacock appeared to be in good condition externally as well as internally, and none showed any sign of damage or dezincification.

- 1 Starboard cockpit drain
- 2 Port cockpit drain
- 3 Galley basin drain
- 4 Engine raw water intake
- 5 Heads basin outlet
- 6 Heads discharge
- 7 Heads inlet
- 8 Paddle wheel log (paddle spins freely when tested from outside the hull)
- 9 Depth transducer (this was unplugged at the time of survey)

Recommendation: inside the vessel, most hoses were fastened to the tails or spigots of the 'seacock' (valves) with just one hose clip. Two is recommended, where feasible (B).

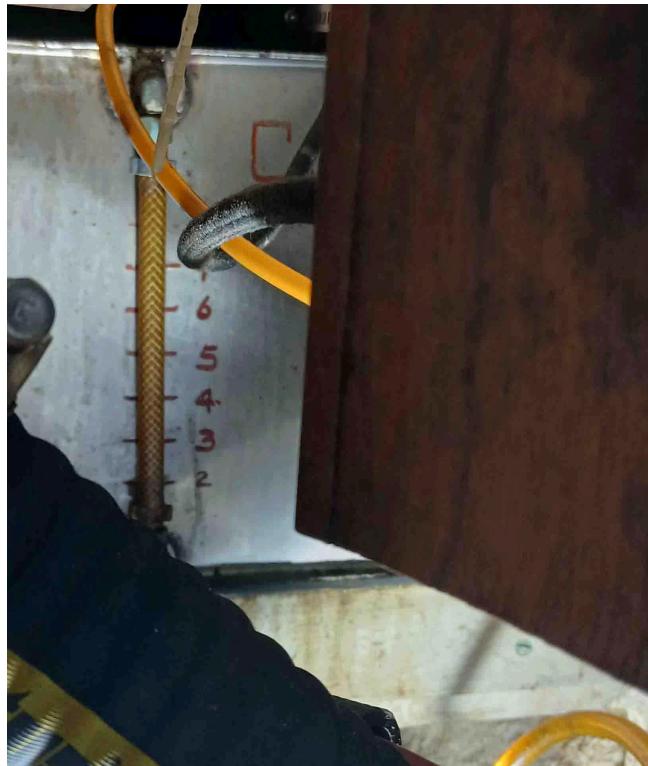
The fuel tank (55 litres according to broker and owner) is in galvanised steel and sits underneath the cockpit sole, with the filler let into the centre of the sole above. The sight 'glass' at the forward end is in clear hosing (see photo below). It was impossible to access, but it's likely this hose is not fire retardant and must be considered a fire risk, particularly if there is no separation valve.

Again, it was not possible to verify due to the tank's position.

Recommendation: replace sight glass with fireproof alternative or fit sender; or retain existing arrangement but fit self-closing valve (A).

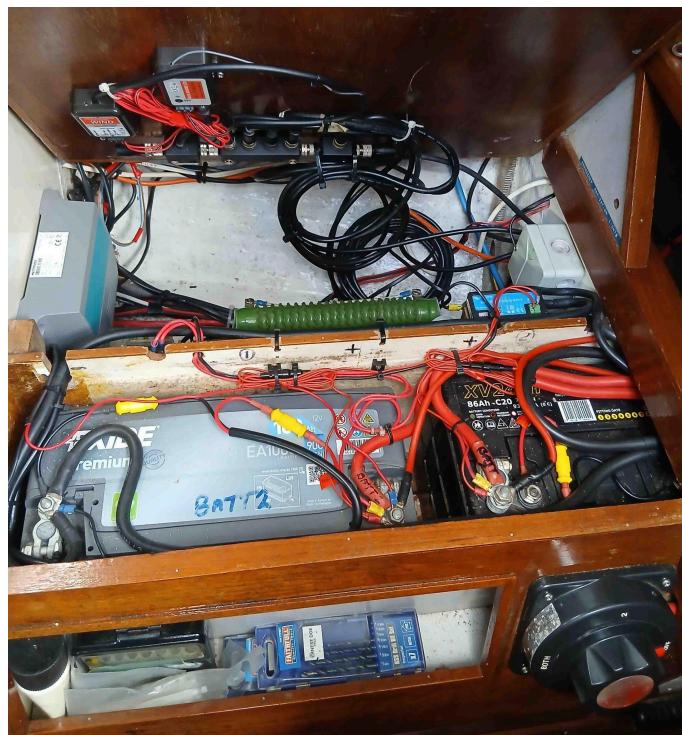
There are two 12V batteries (sealed lead acid) in a dedicated compartment under the chart table, with a cut-off/selector switch below. cut through the saloon back and accessible from the chart table. Voltage was tested after 40 minutes with the cabin and navigation lights on and read 12.23 and 12.46 volts, indicating that they are in good condition and holding their charge. Batteries were firmly secure in place, and generally neatly wired, with some of the wiring unnecessarily long.

Recommendation: shorten wiring runs in the 12v system (B).
