REPORT OF A CONDITION SURVEY CARRIED OUT ON

Pecheur, 1971 Parkstone Bay Cruiser

17 July 2025, ashore in Bournemouth, Dorset UK

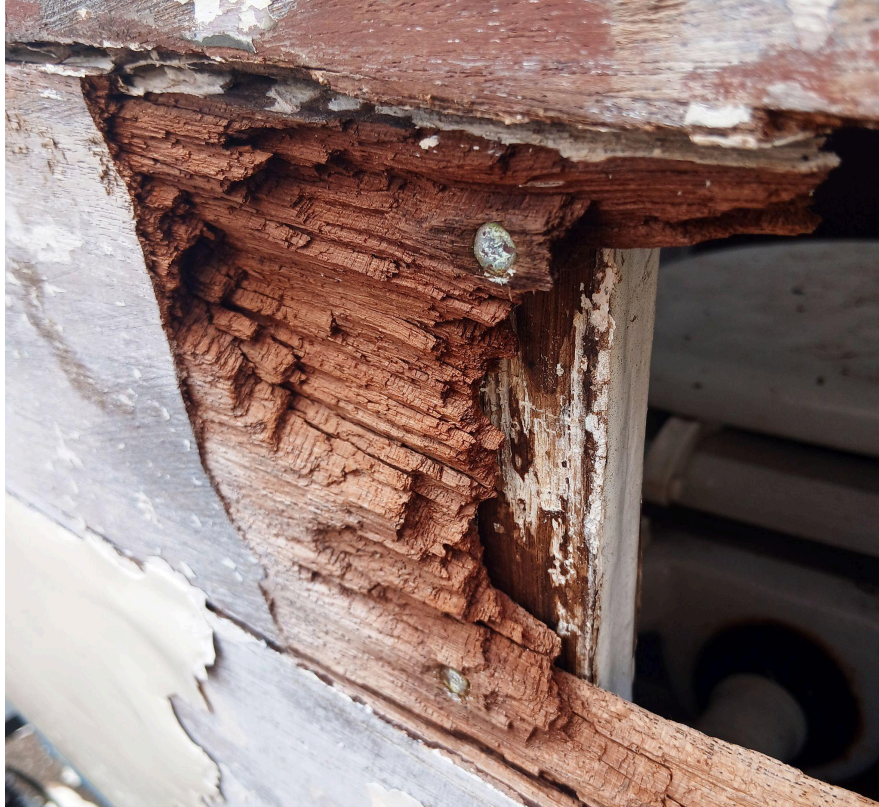
**D1 Planking, rails and bilge keels**

The hull of *Pecheur* is traditionally planked in a single layer of carvel, with 15 planks each side. These are in timber of the mahogany family and 19mm in thickness. The planks are fastened by rivets to the internal members. The planking is rotten above the waterline on both sides, particularly the port side, as evidenced by extensive hammer sounding and spike testing. There is also a square hole in the port side (pictured above) where it is thought the boat has suffered some damage in the past and been crudely re-patched, but given that all planking above the waterline will have to be replaced anyway, the point is moot.

The planking below the waterline is in considerably better shape, and at the very least would serve to hold the boat's shape while the planking above is replaced plank by plank. The true state of the planking below the water will only become fully apparent once work is underway, but it's likely much of it will be kept. The small bilge keels (for tracking and damping rather than taking the ground) showed some signs of decay, as did the half-length rails halfway up the freeboard on each side towards the stern. These should all be replaced.

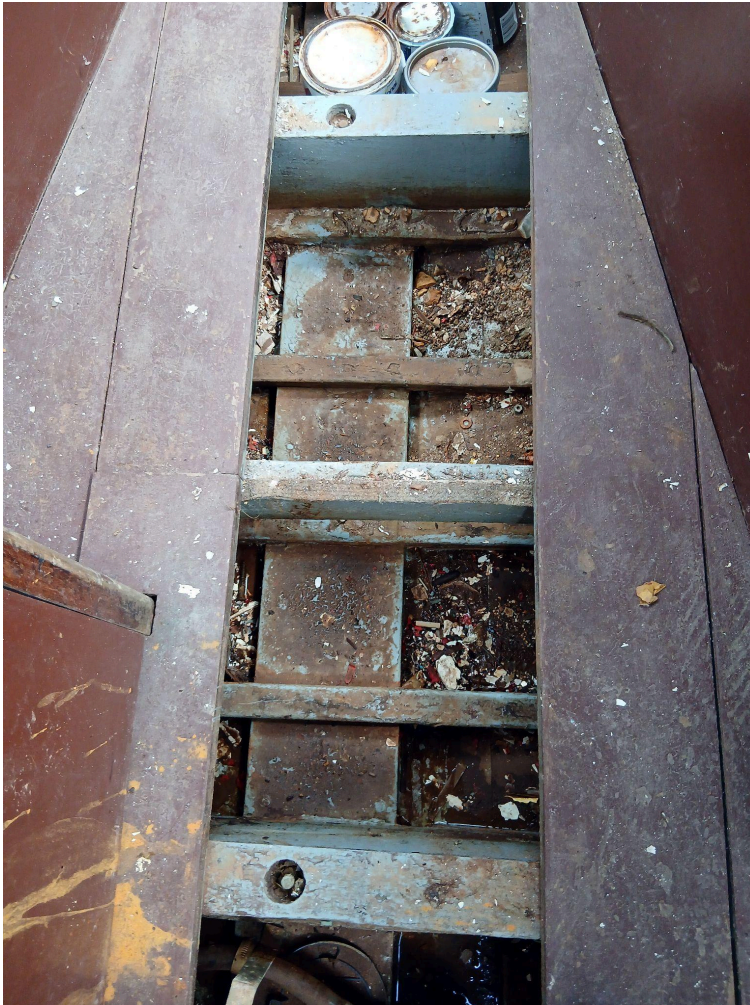
D2 Centreline

The boat's internal skeleton is made up of an internal hog (150mm wide by 15mm deep, pictured left), atop a thin, shallow, full-length timber keel. There are small spots of softness in the hog, and it is likely that some new sections will need to be scarphed in; most of the hog, however, sounded well under hammer sounding. The stem was hammer sounded and showed no signs of decay, although the timber has become somewhat denatured after years of exposure to the elements without sufficient coating. At least partial stem replacement should be undertaken. The inner face of the stem (or 'apron') could be seen above the anchor locker and no sign of decay was found. The external keel showed no obvious sign of decay, but its underside was impossible to access, due to the boat's position low to the ground on its road trailer.

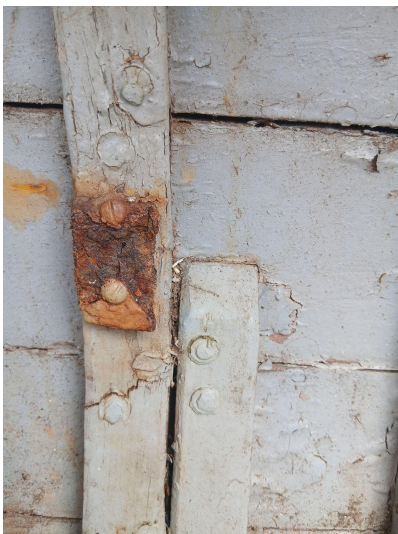
D3 Transverse stiffening (floors, ribs and bulkheads)

The boat is stiffened by steamed-oak ribs of 30mm width and 17mm depth on 165mm centres. Each of these is supported by a 40mm x 17mm doubler or 'sister rib' running from outboard of the hog to just above the turn of the bilge. Sister ribs or frames are usually retrofitted to return strength that was lost to a crack in the original member; but given the ubiquity of them in this boat, it's possible they are from the original build. Additionally, there are solid timber floors of 60mm width and 150mm depth running the length of the boat on 720mm centres. By and large, this is typical construction for a vessel this size. Nearly all ribs are either cracked or rotten, and a complete reframe will be needed. There is a full-width bulkhead near the transom, forming the forward end of the lazarette; the main bulkhead that forms the aft end of the cabin; and one further partial bulkhead near the bows. All are in 10mm plywood and should be replaced as a matter of course.

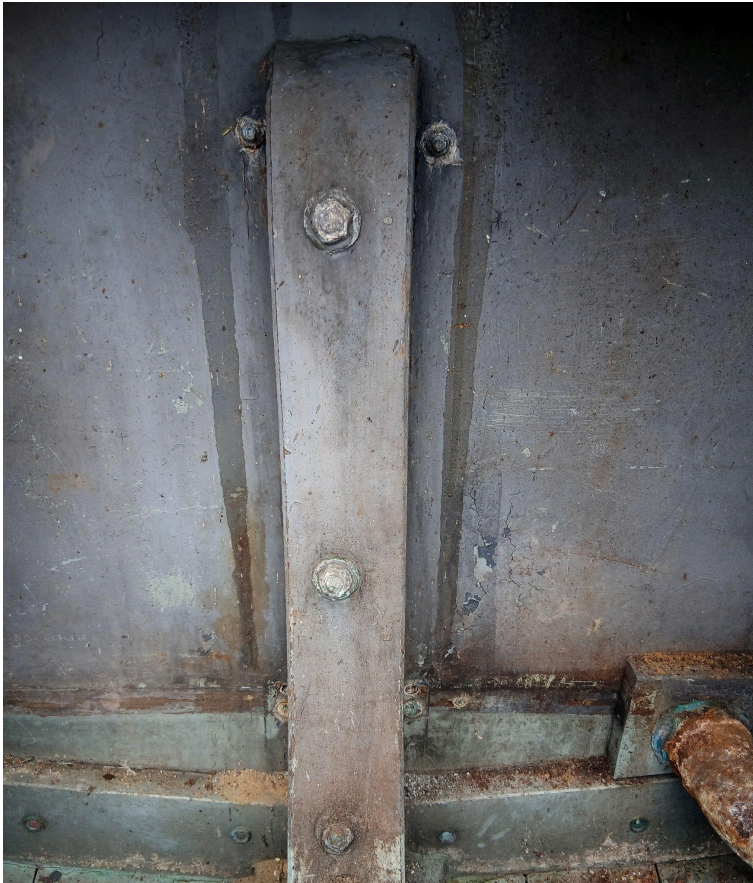
D4 Beamshelf, stringer, beams and knees

There are two principal longitudinal stiffening members: a beamshelf of 27mm width and 80mm depth running the perimeter of the hull just below deck level and a stringer of similar dimension running the perimeter of the boat near the turn of the bilge. Both these important members are soft, particularly towards the join with the transom, where exposed end grain has allowed the ingress of water. They will need replacing in their entirety, along with most of the rest of the vessel above the waterline. The transom's junction with the hog is reinforced by a transom knee of 70mm width (pictured) which hammer-sounded well, showing no apparent decay. The aft quarter knees in 50mm-wide timber were

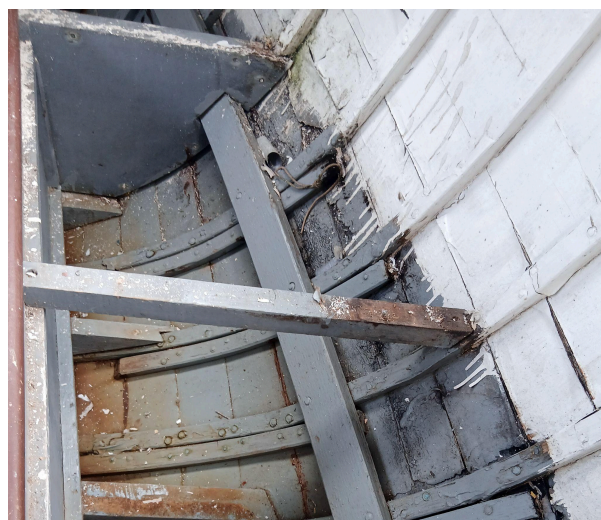
similarly sound, but these are perhaps moot points given that the scale of any rebuild will prompt their replacement. Photo below shows a section of the starboard stringer, as seen looking forward from the aft of the cabin.

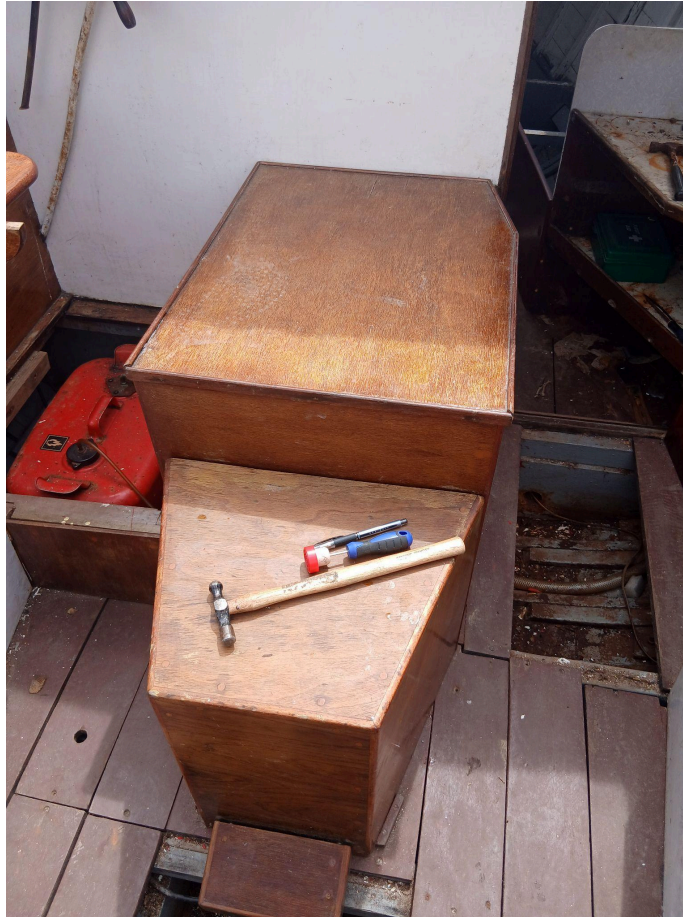
E COCKPIT

The cockpit contains a small lazarette, two traditional upright mooring cleats in solid timber, and seating formed of 10mm-thick plywood on solid wood carcassing, all of which would be replaced as part of a rebuild. The flip-down helm seat in mahogany is in serviceable condition with a big split that needs some filling, but it's perhaps worth saving. Similarly, the boxing around the engine (see photo above) and the door to the cabin could perhaps be cleaned up and re-used, given that it's likely the same engine will be returning to the same position after rebuild.

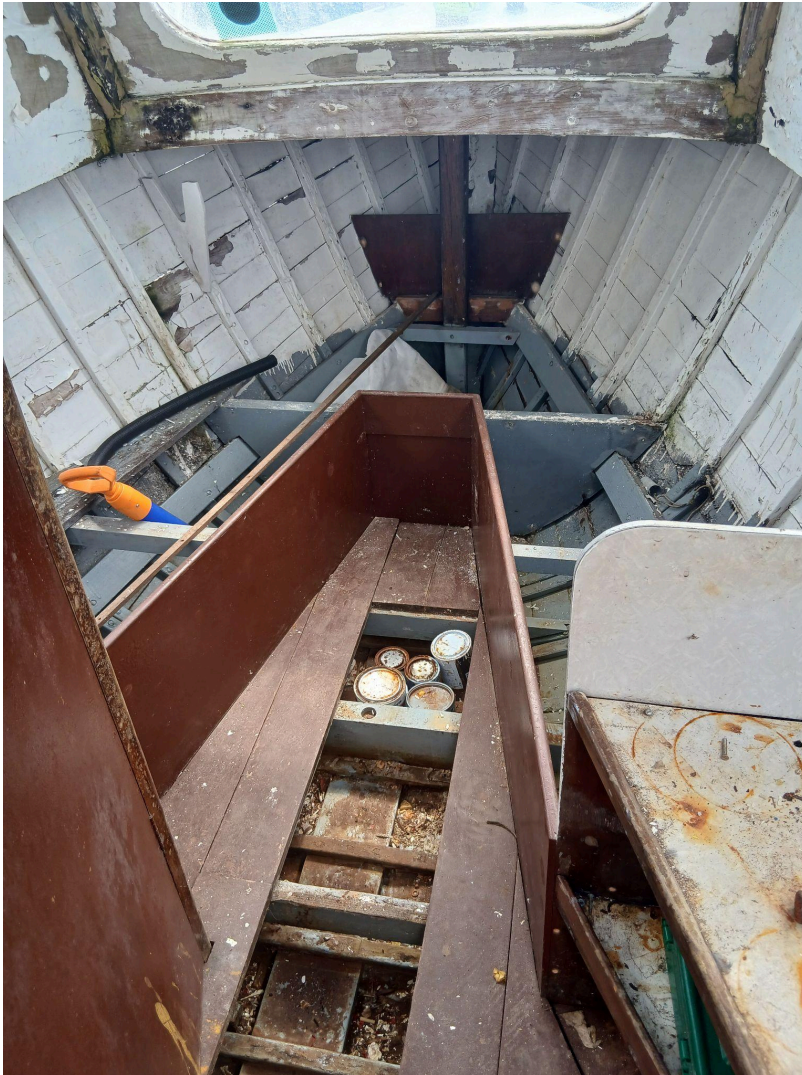
F CABIN

This is formed of mahogany sides and front, with a plywood coachroof, the whole structure reinforced by solid wood quadrant pieces, carlins and deckbeams. There is a single lifting hatch. Condition here is variable, but the entire cabin trunk needs removal and dismantling to refinish, and at that stage, the most likely course of action will be to replicate most material before reinstating. The cabin trunk is of a size and shape that has held its appeal well, so this is potentially a relatively straightforward task, using the original as template. NB: the cabin sides run continuously into the cockpit coamings. There is a distinct line separating two different shades, but this is not evidence of a retrofit: it is simply uneven UV bleaching caused by prolonged

periods under a cockpit cover. These two sizeable members (one each side) might be salvageable with a strip and refinish.
