PRE-PURCHASE SURVEY

XXXXXXX, 1980 Twister 28 Mk II

24 October 2025, at Lochin Marine, Newhaven, East Sussex, UK

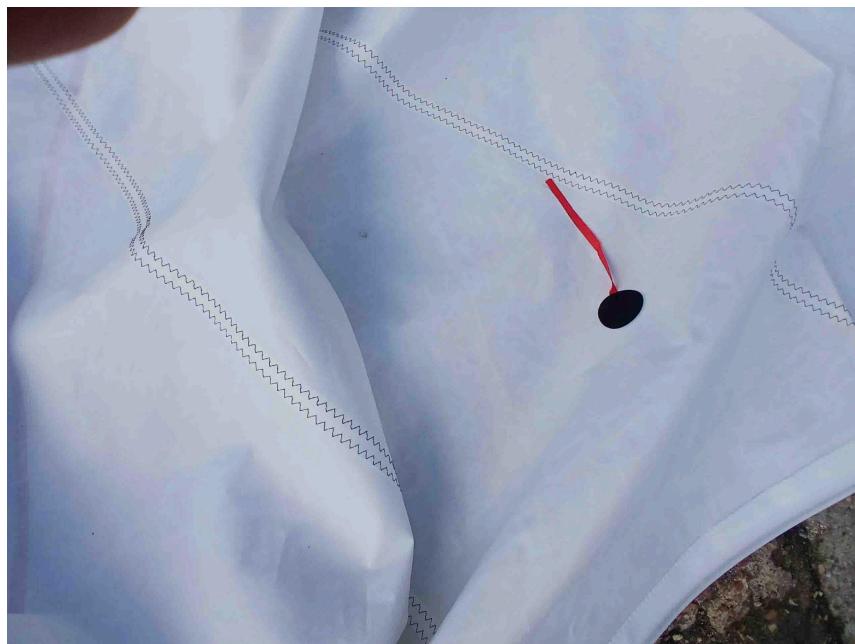
The genoa was in its bag in the forepeak at the time of survey and was inspected without unbagging. The sail appeared to be in good condition. The mainsail was taken out of its bag and inspected on the ground, and found to be in good condition. The mainsail is hoisted conventionally and lowered into lazy jacks and reefed by reefing lines inside the boom. Any testing on the day was necessarily very limited, but raised no concerns. There was no spinnaker on board at the time of survey.

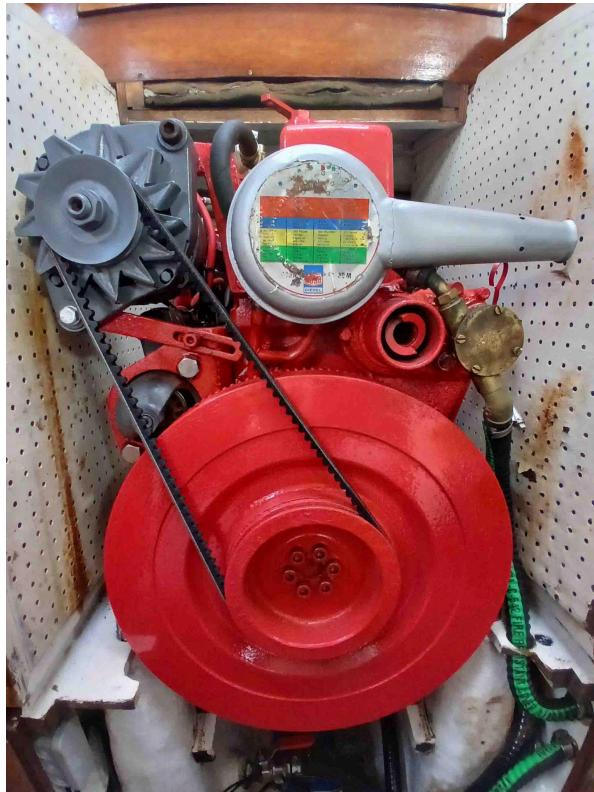
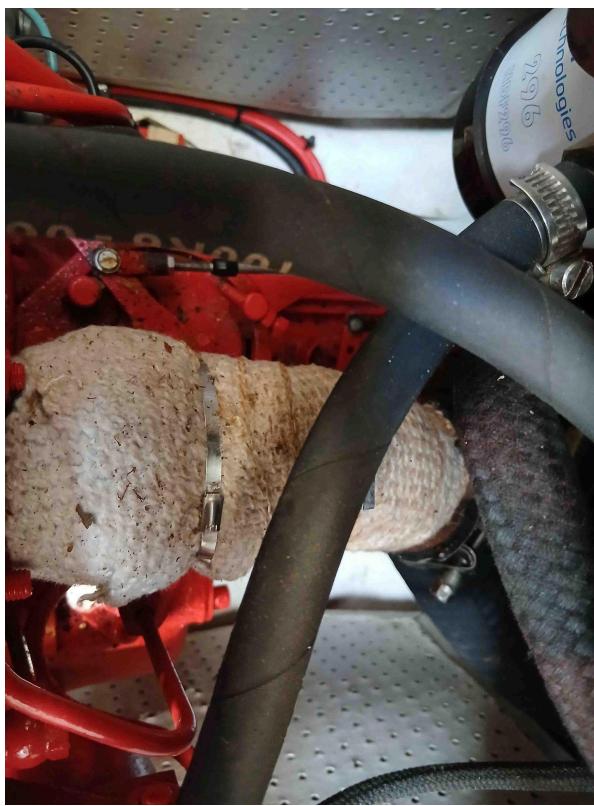
The vessel has a Bukh DV10 one-cylinder diesel engine developing 10hp, driving the three-bladed propeller via a straight shaft. Cooling is directly by raw water. The control panel indicated 2,191 engine hours. The engine was given an overhaul in 2024, with various new parts and a repaint. It is secured by four flexible mounts, all of which were tested and found sound. No signs of oil or other leaks were found on the removable sump beneath the engine. The exhaust injection bend appeared sound externally, with surface corrosion fitted under a flame-retardant lagging. NB: as a result of this lagging, it was impossible to inspect the underside of the elbow to check the severity of corrosion. The shaft coupling showed what appeared to be surface corrosion. The boat was on dry land, so the engine was not tested at the time of survey. Photos on the next page show installation and lagging around the exhaust mixing elbow.
